SRH-2009-44

Profile Survey of the Sandy River for Marmot Dam Removal

U.S. Department of the Interior
Bureau of Reclamation
Technical Service Center
Denver, Colorado

December 2009

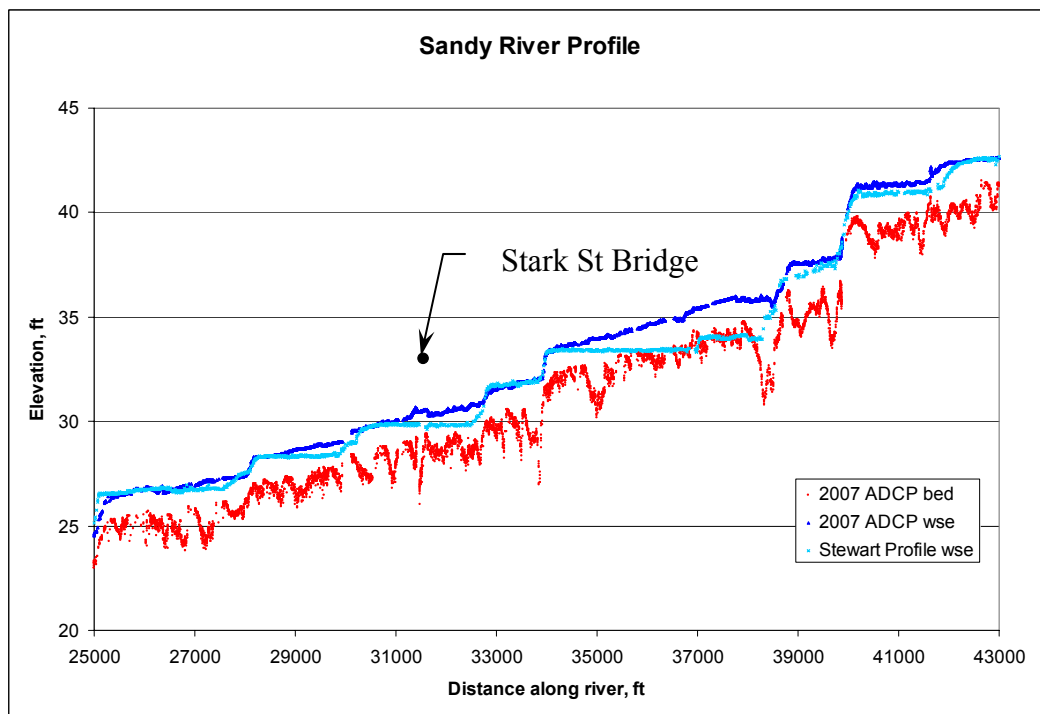
There are some interesting trends in the water surface profiles from 2004 (Stewart, 2006) and 2007 upstream from Oxbow Park. Upstream from Oxbow Park, the two profiles are very similar and plot nearly on top of each other. This indicates that the rapids were not significantly changed by the high flows in November 2006. Conversely, downstream from Oxbow Park there are significant difference between the two profiles. In this reach the riffle crests are nearly identical but the water profiles through the pools are very different. In the 2004 survey the pools were very flat and the profile has a stepped appearance. In the 2007 survey the pools are much steeper. During the 2007 survey many of the pools in this reach were very shallow and filled with sand. It is possible that the higher water surface slope through this reach in 2007 is the result of sand deposition in the pools that has resulted in increased water surface elevations.

Figure 6 Comparison of 2004 and 2007 profiles in the Oxbow to Lewis and Clark reach.

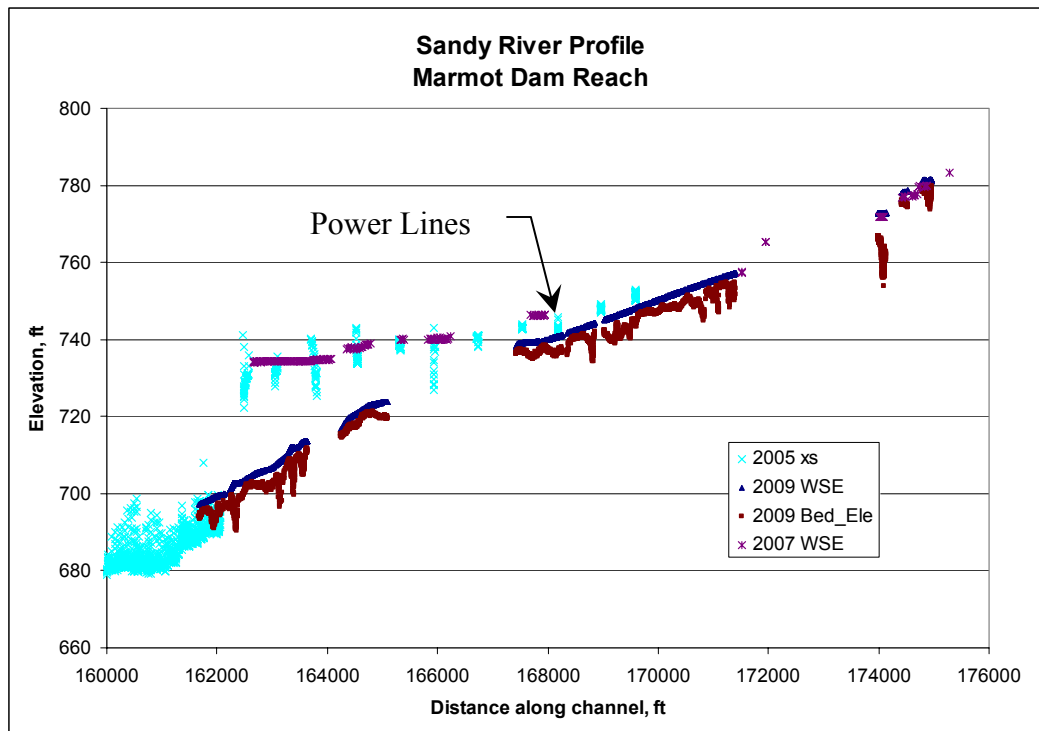
There have been several moderate high flows on the Sandy River since removal of Marmot Dam. During these flows a large amount of sediment has moved out of the former reservoir pool. Near the dam, the channel adjusted quickly. Immediately downstream from Marmot Dam the channel aggraded while bed elevations upstream from the dam decreased significantly. Figure 7 shows a comparison of water surface and bed elevation data taken before and after Marmot Dam was removed in fall 2007. Bed elevations in the upstream end of the reservoir have not decreased as much as downstream and there is a distinct slope break about one mile upstream from the dam near the power lines. Upstream from the slope break there has been minimal down-cutting and there is little separation between the normal reservoir pool line on the banks and the current water surface. Downstream from the slope break there is more separation between the normal pool elevation and the current water surface.

Figure 7 Comparison of channel profile near Marmot Dam before and after dam removal.

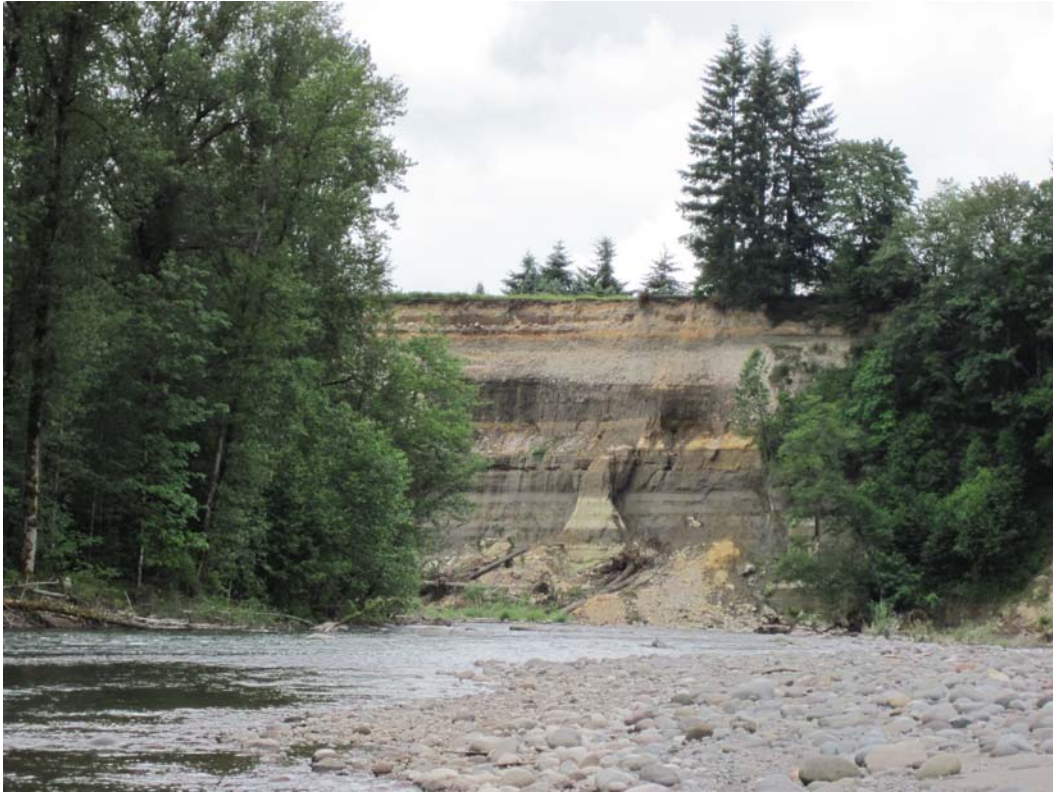
most likely caused by bank erosion or mass wasting of high banks as seen in Figure 8.

Figure 8 Bank failure downstream from Revenue Bridge.

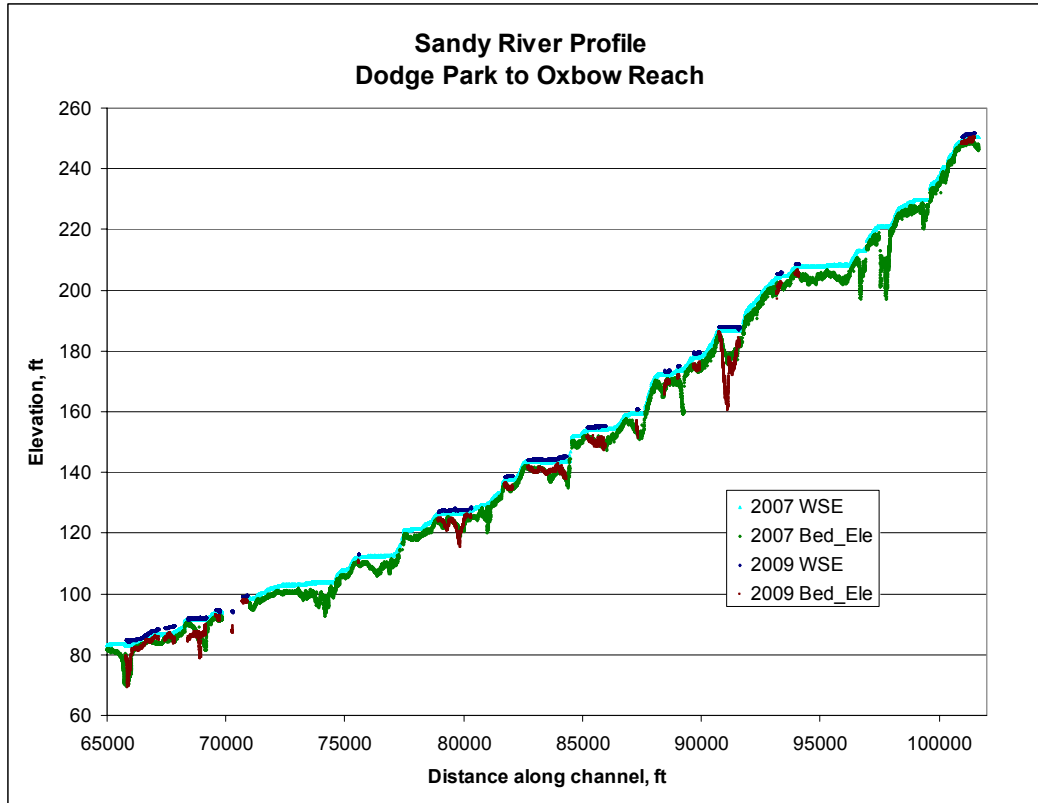
The Dodge Park to Oxbow reach does have multiple profiles that can be compared, but this reach is similar to the upstream reach in that there are no signs of sediment deposition that can be attributed to Marmot Dam. Profile comparison (Figure 9) shows very little change in bed elevation before and after dam removal. Areas with significantly different bed elevations in the two surveys are attributed to changes in boat path and not sediment deposition.

Figure 9 Comparison of channel profile between Dodge Park and Oxbow Park before and after dam removal.

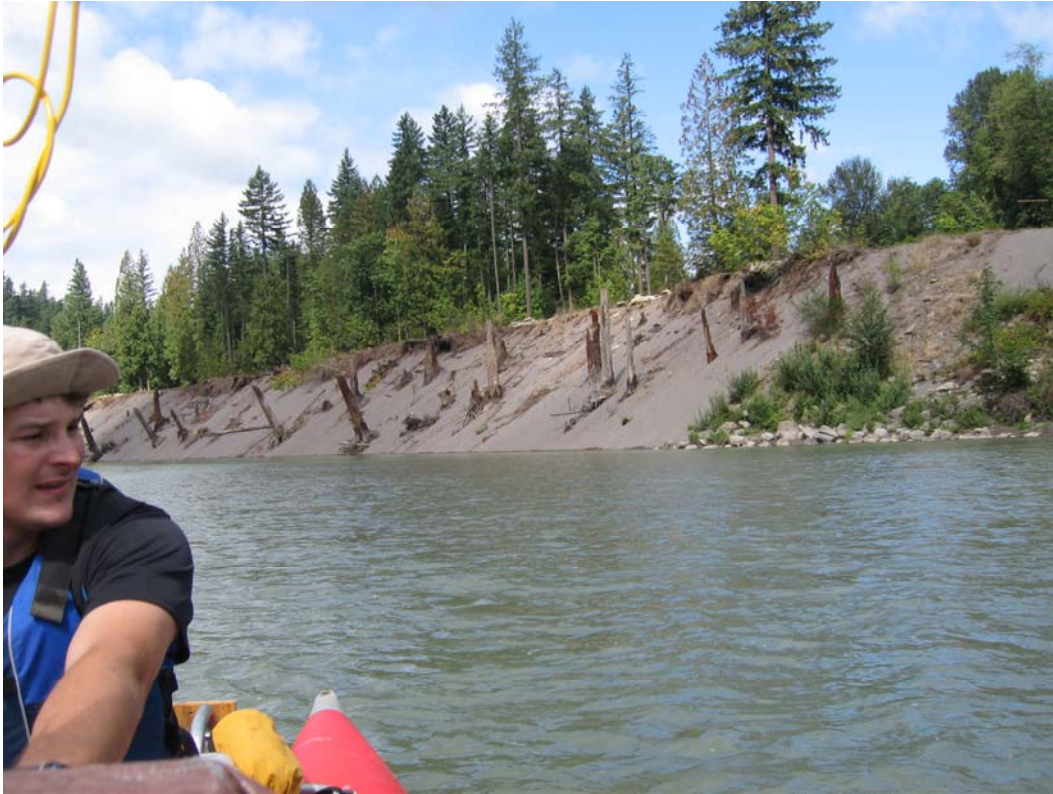
General observations of river features made during the 2007 and 2009 surveys are summarized in this section. First, there is a distinct change in bank material composition that first appears near Oxbow Park. Upstream from this area the banks are mostly composed of bedrock with some terraces composed of cobbles and small boulders. Beginning a short distance upstream from the Oxbow Park boat ramp a buried terrace (Figure 10) with large trees appears along the active channel. The terrace is approximately 30 to 40 feet high and is primarily composed of sand. The river appears to be actively eroding many of these sand banks. Local accounts of the November 2006 flood suggest that the river has laterally migrated into many of these banks. Aerial photography that predates the 2007 survey supports this conclusion as the boat path from the surveys is sometimes in areas of dense vegetation that have been eroded. It is likely that the sand found in the pools downstream from Oxbow Park is from these sand banks and was not transported into the reach from further upstream.

Figure 10 Picture of tall sand bank with buried trees in the Oxbow reach.

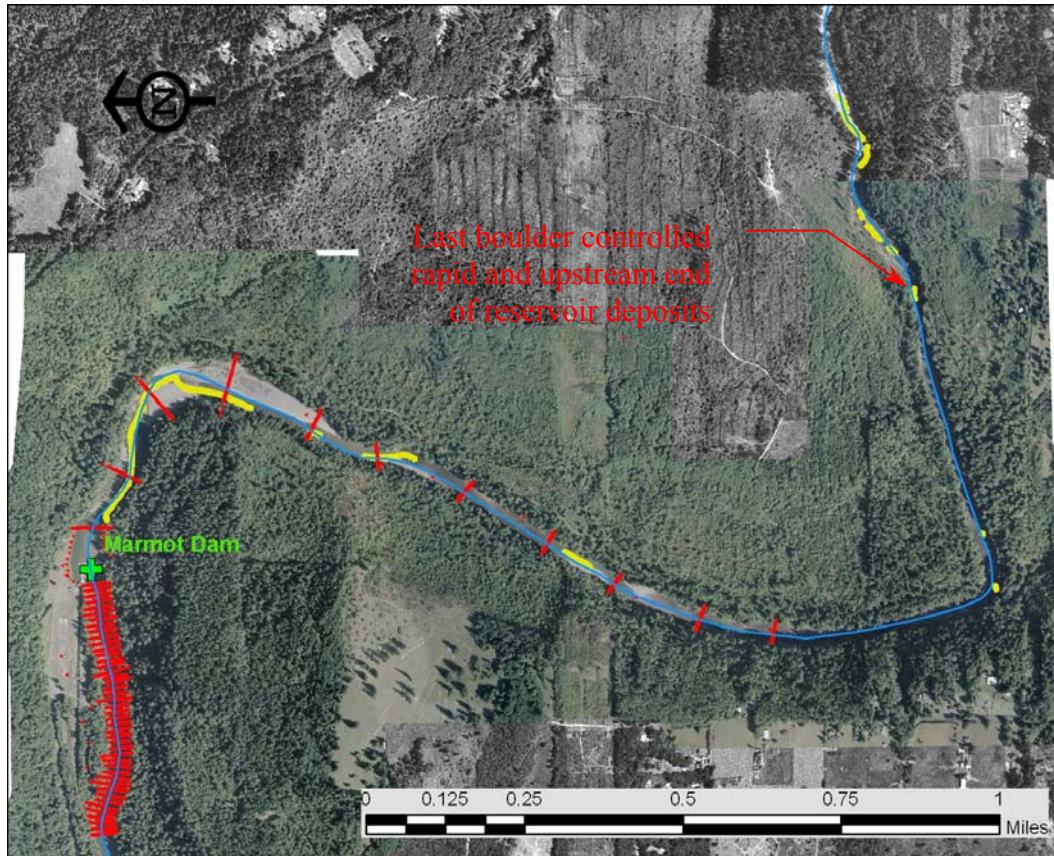
Another observation that is worth noting is the location of the reservoir influence upstream from Marmot Dam. Near river station 173,000 there is a noticeable change in the composition of the rapids. Upstream from this point the rapids are composed of boulders or bedrock (Figure 11). Downstream from this point the rapids give way to riffles and there are no large boulders visible in the riffles. The drops become large piles of cobbles and small boulders. Alternating and mid-channel cobble bars also appear. It is likely that there are boulders here but they have been buried by reservoir sediments.

Even though there has been significant vertical change since Marmot Dam was removed, the riffle composition in the majority of the reservoir pool has remained unchanged. The riffles are still composed of mostly cobbles. Some bedrock and large boulders have been exposed in the reservoir pool but most of the riffles and riverbed are free from large boulders. Exposed bedrock currently has more affect on flow direction and is not significantly affecting the vertical stability of this reach as the river has not yet down-cut to boulders and bedrock that likely underlies the reservoir sediment deposits.

Figure 11 Extent of reservoir influence (Red lines indicate locations of cross sections surveyed in 2005 or 2006).
